MJN Home Inspections, Inc.

Home Inspection Report

123 Example Ln

Inspected on Tue, Mar 16 2021 at 9:53 PM

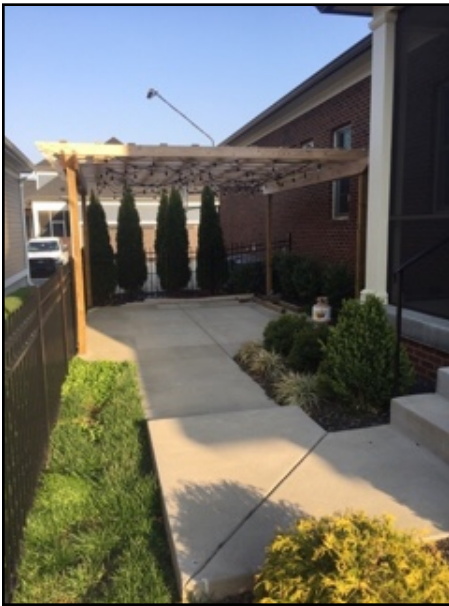
Figure 1-1

i Comment 1:
 Patio and pergola are in acceptable condition. Keep pergola maintained.

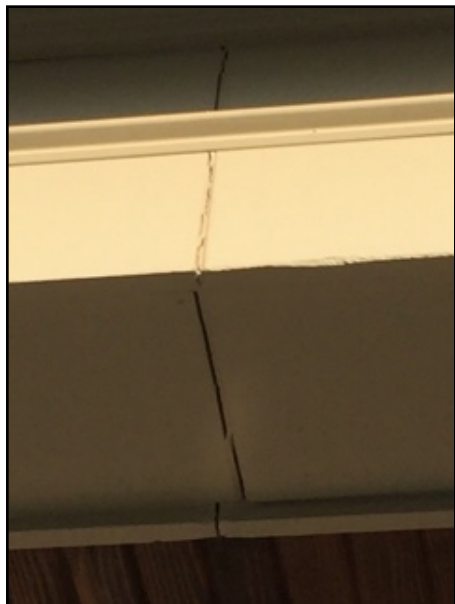
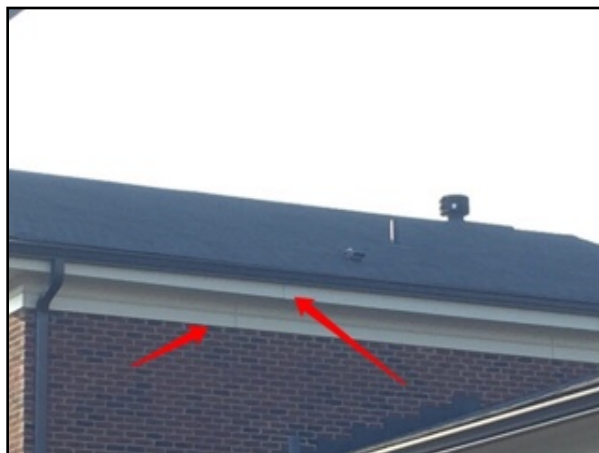
Several areas of gaps in exterior trim. Have caulked and painted to protect from weather.

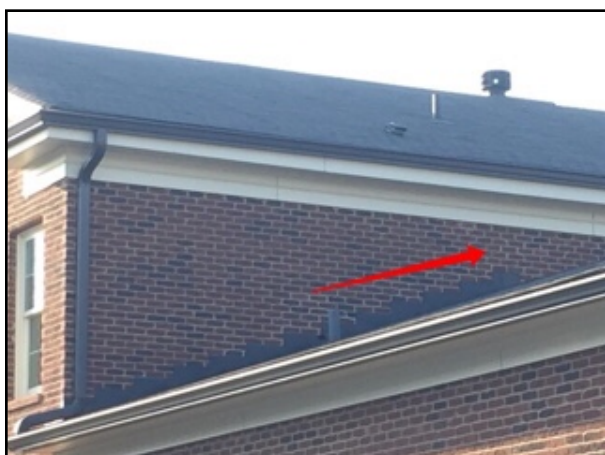
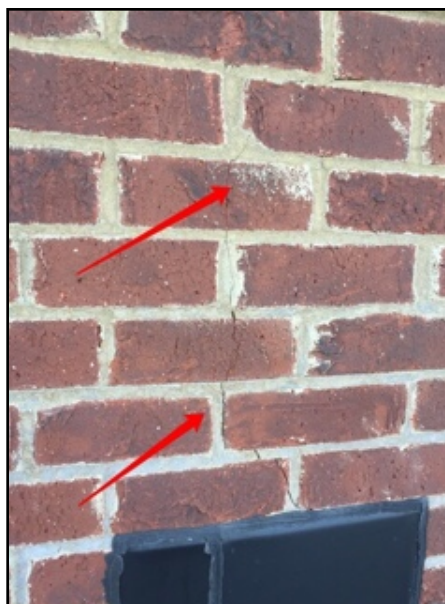
There are hairline brick cracks above rear roof. This is not a structural issue. Monitor and repair by tuck pointing if needed.

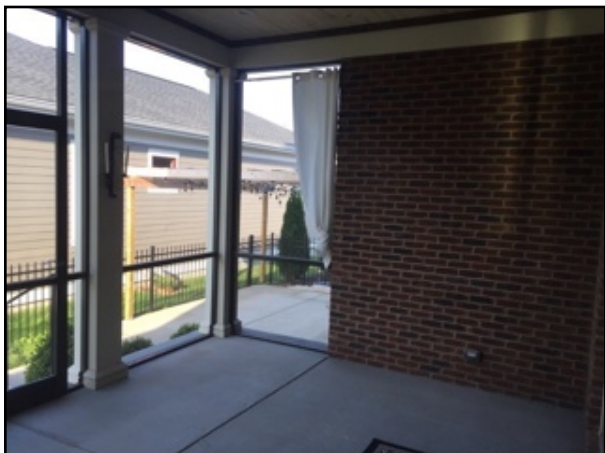
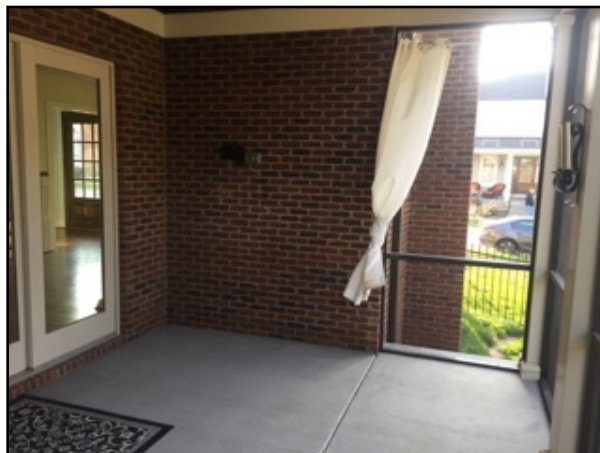
Comment 4:
Screen porch is in acceptable condition. Ok.

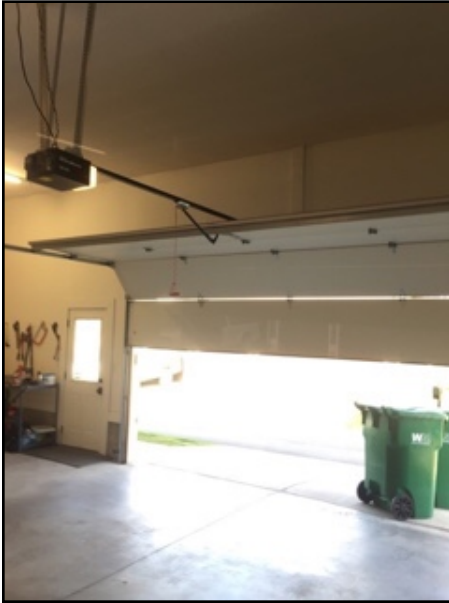
Figure 5-1

Comment 5:
Vehicle door and opener operates as expected.

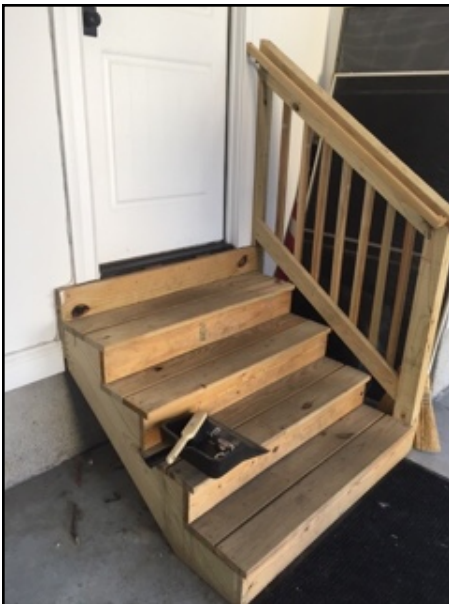
Figure 6-1

Comment 6:
Steps in garage are missing handrail & guardrail. Install for safety.

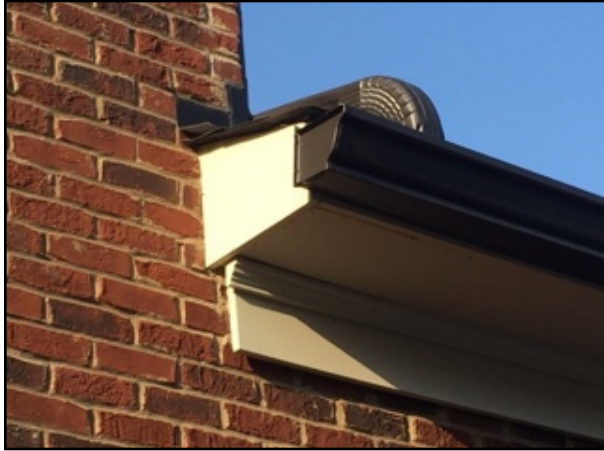
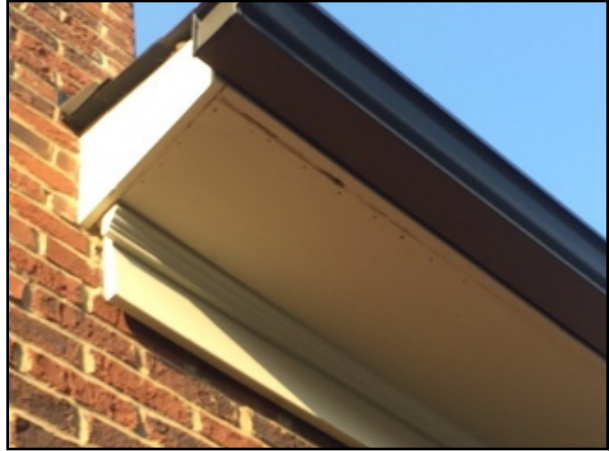
Prior repairs to rear right soffit. Have owner explain when and why repairs were made. Monitor.

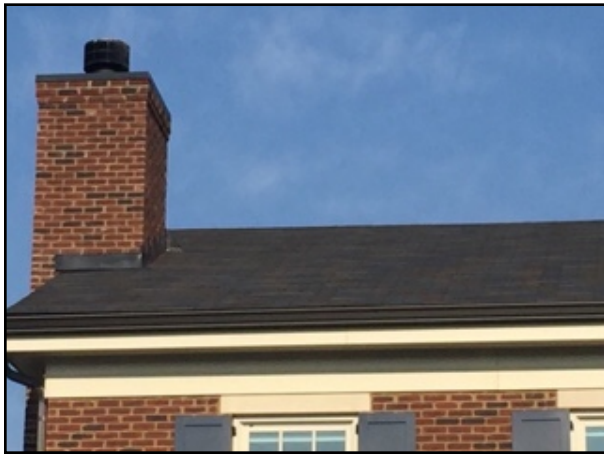
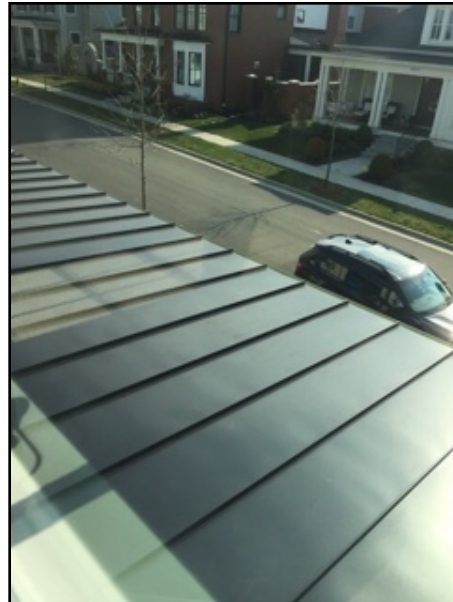
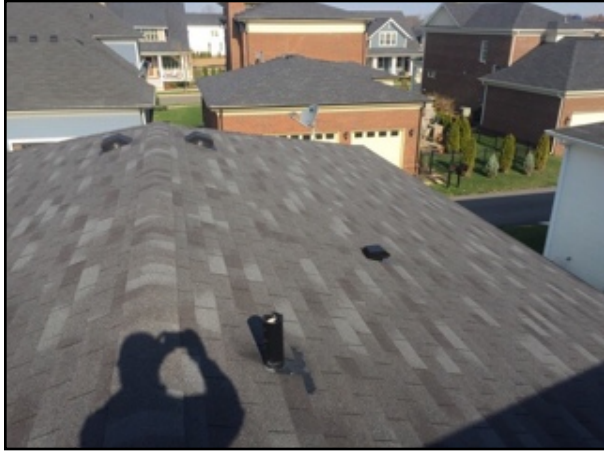
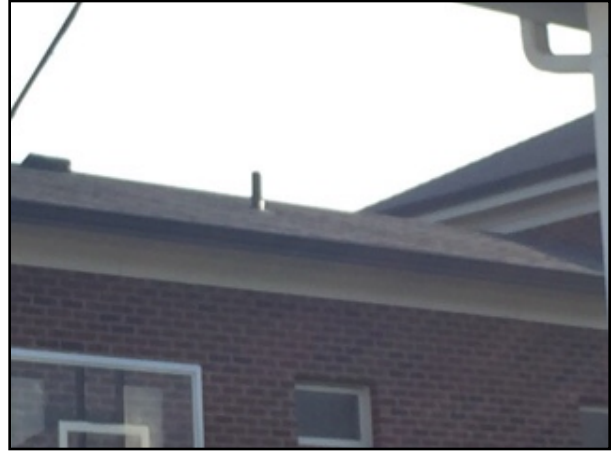
Visible roofing and gutters are in acceptable condition unless otherwise noted.

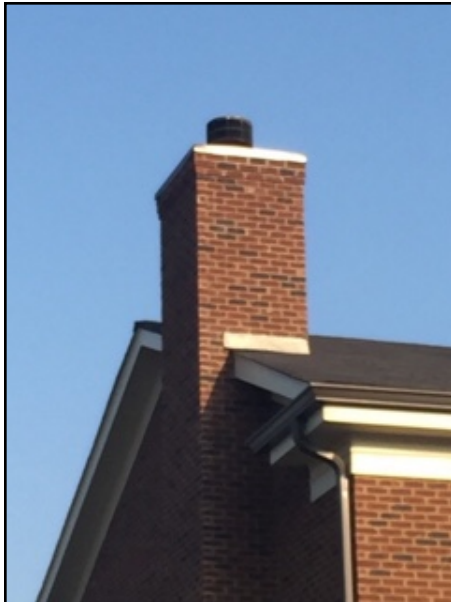
Figure 9-1

Comment 9:
Chimney is in acceptable condition. Ok.

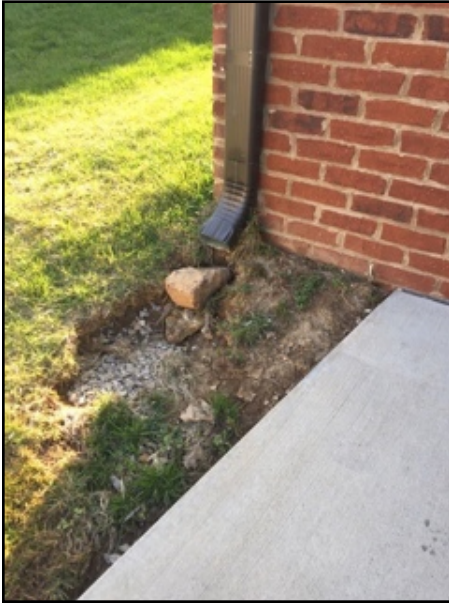
Figure 10-1

i Comment 10:
Rear garage downspout washing out soil. Install splash block and monitor.

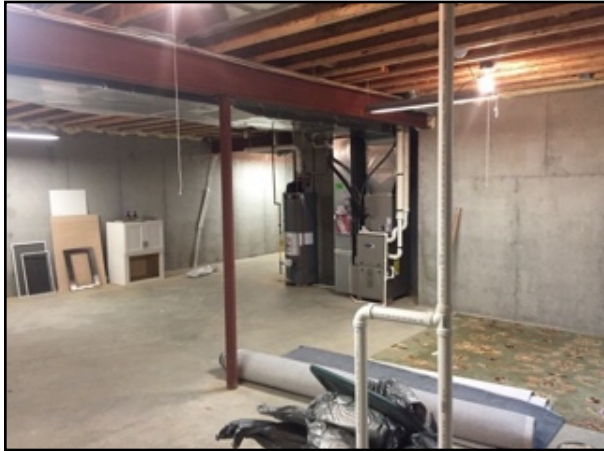
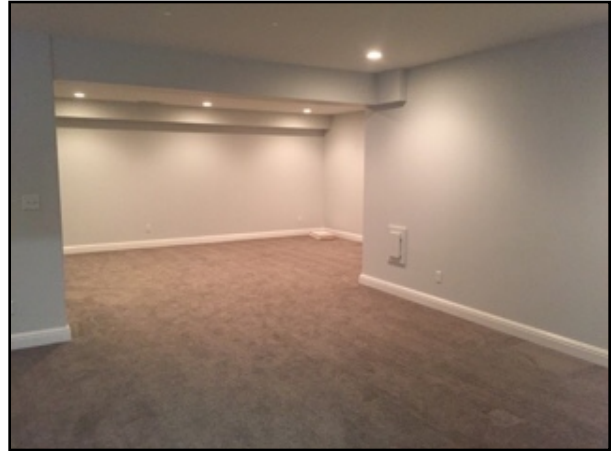
Majority of basement is finished with paneling, drywall and/or carpet. Very little of foundation is visible to inspect.

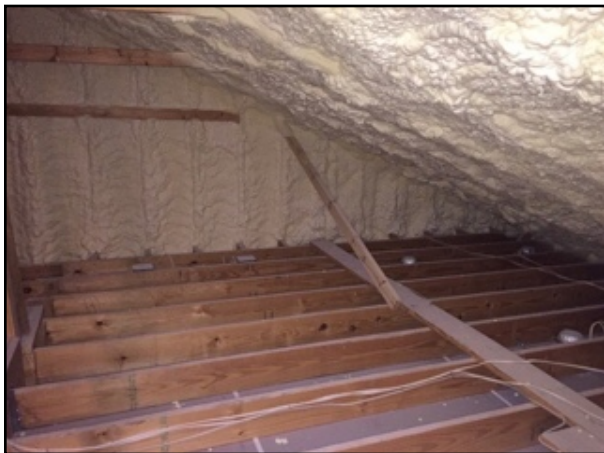
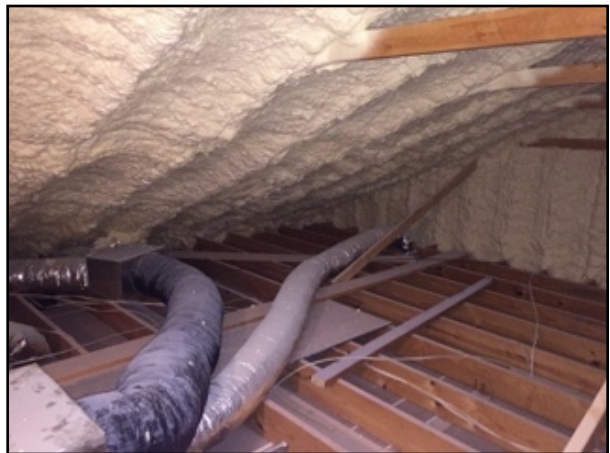
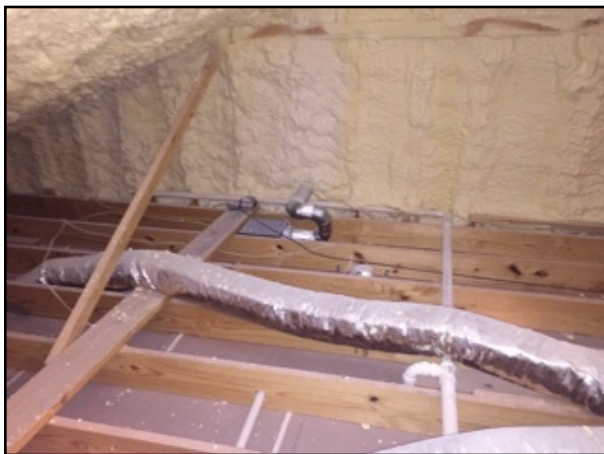
View inside attic. Ok. Most of roof structure was covered with insulation and was not visible.

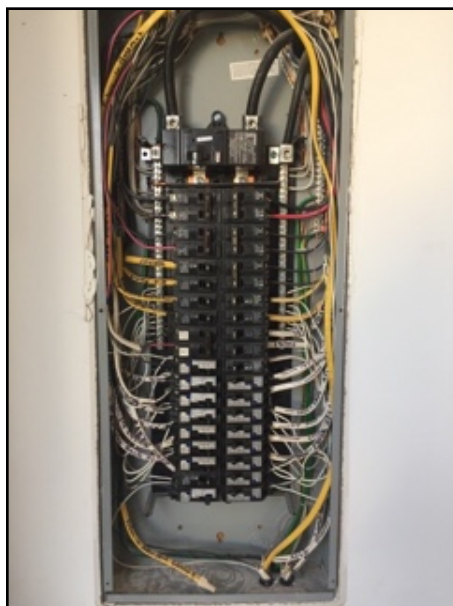
Figure 14-1

Comment 14:
Inside electrical panel. Ok

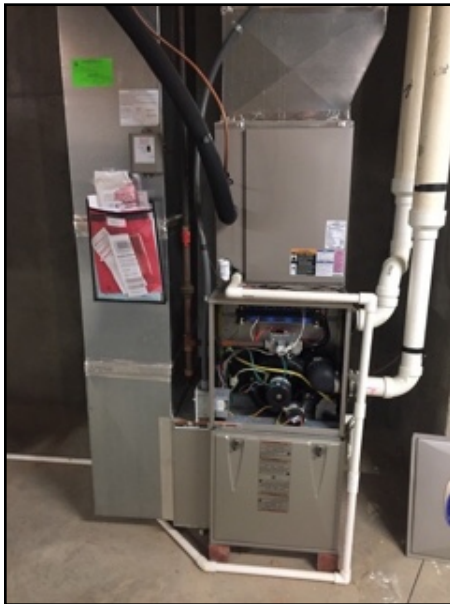
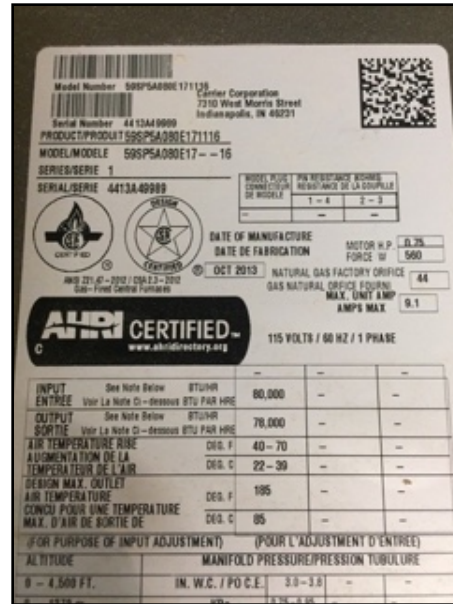
Comment 15:
Furnace and data plate. Operates as expected.

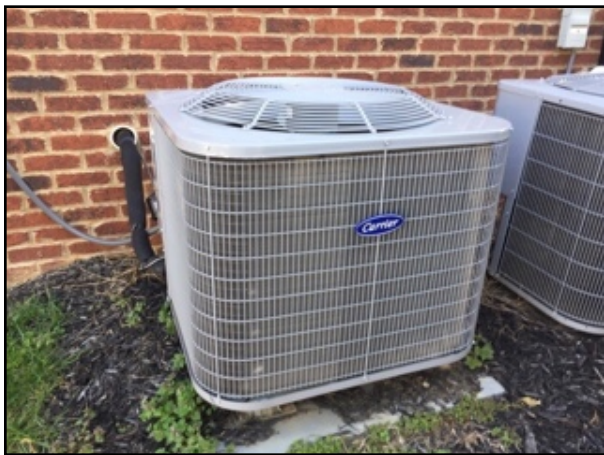
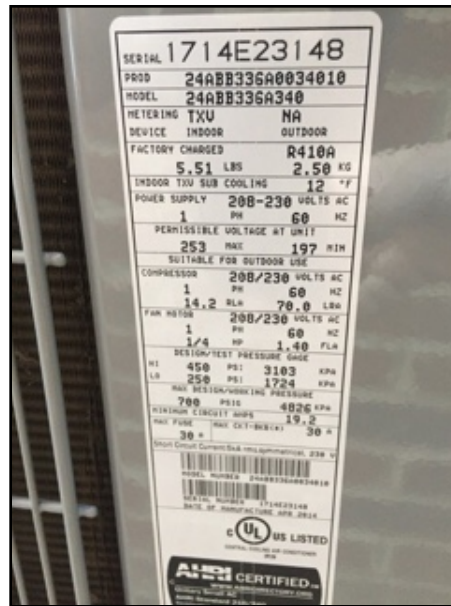
Comment 16:
AC unit and data plate for basement unit. Operates as expected.

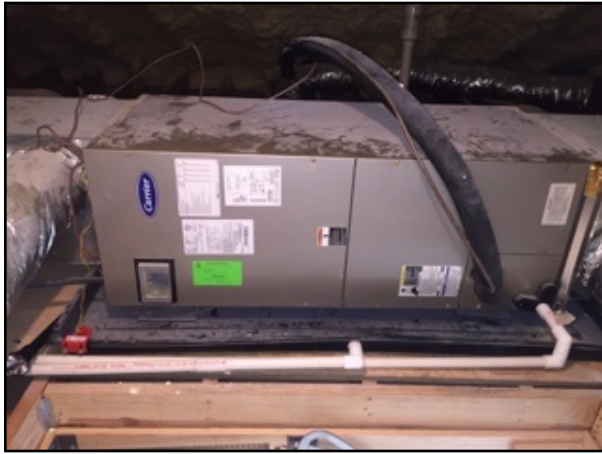
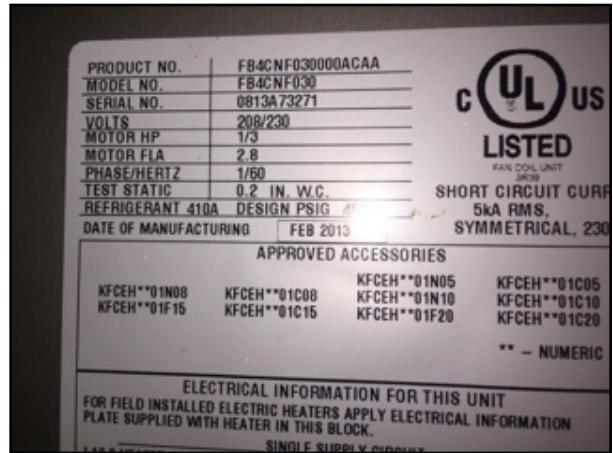
Heat pump and data plate. Operates as expected.

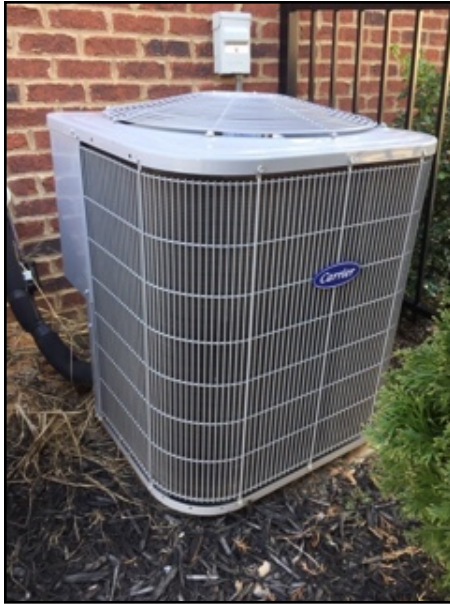
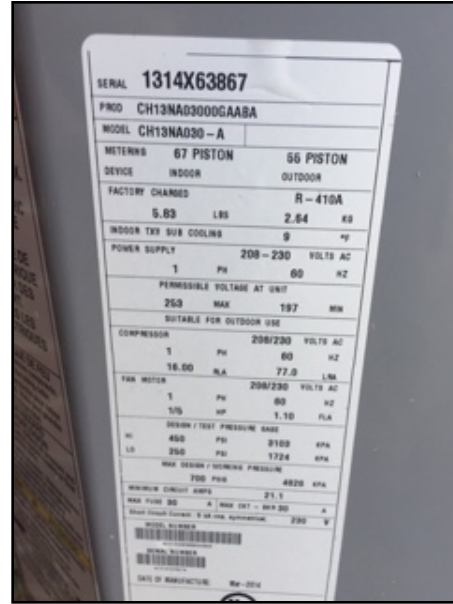
Heat pump and data plate for second floor. Operates as expected.

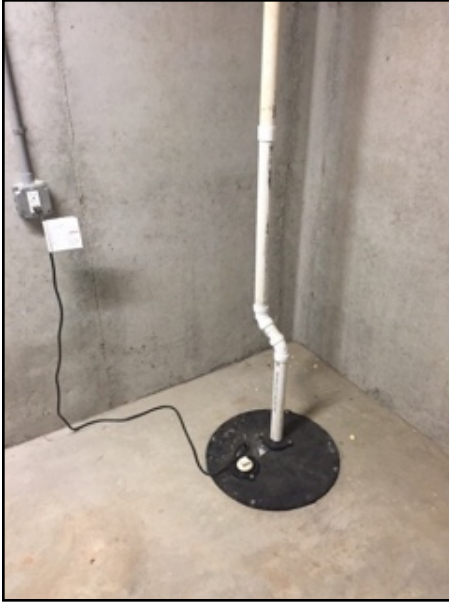
Figure 19-1

Sealed sump pump is present. Unable to operate in order to inspect.

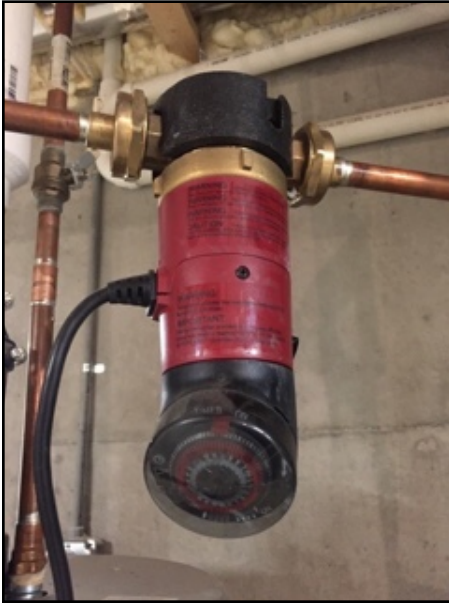
Figure 20-1

Comment 20:
Hot water circulation pump installed. Appears to operate as expected.

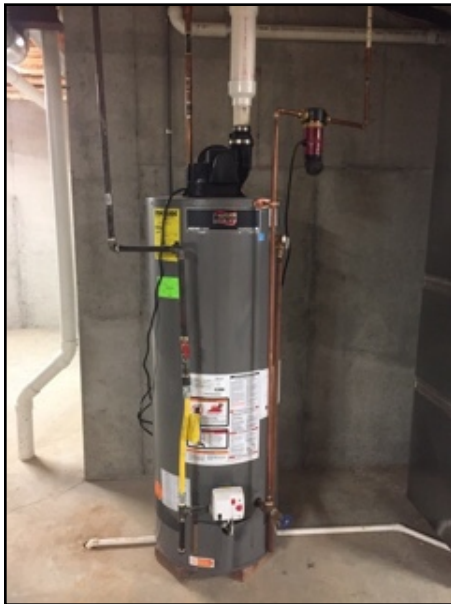
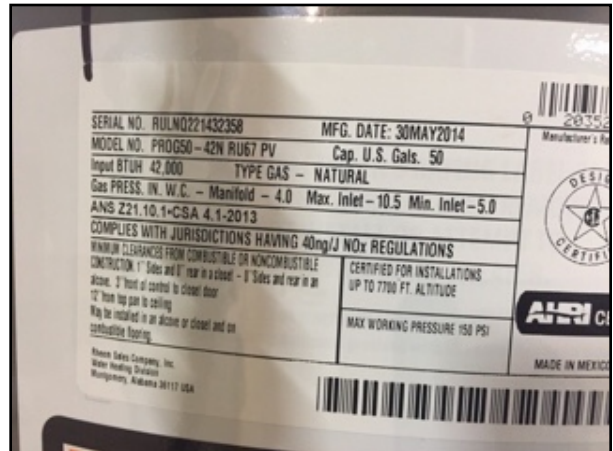
Water heater and data plate. Operates as expected.

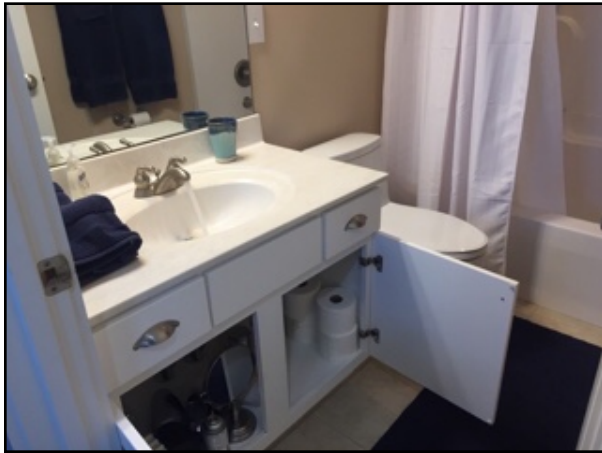
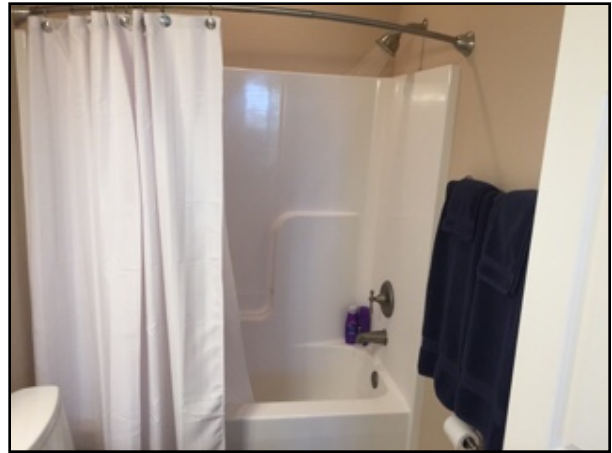
Comment 22:
Hall bath fixtures operate as expected. Ok.

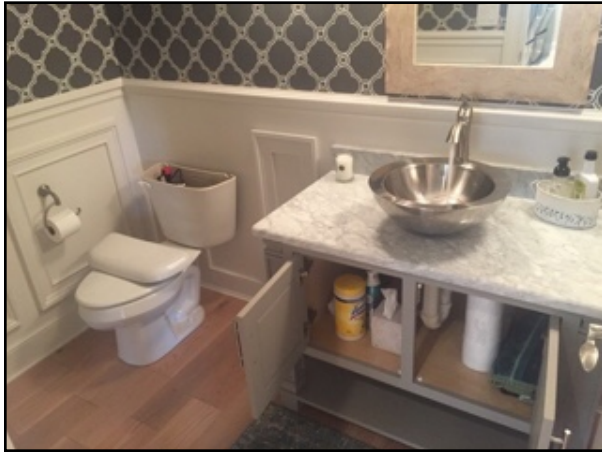
Figure 23-1

Half bath fixtures operate as expected. Ok.

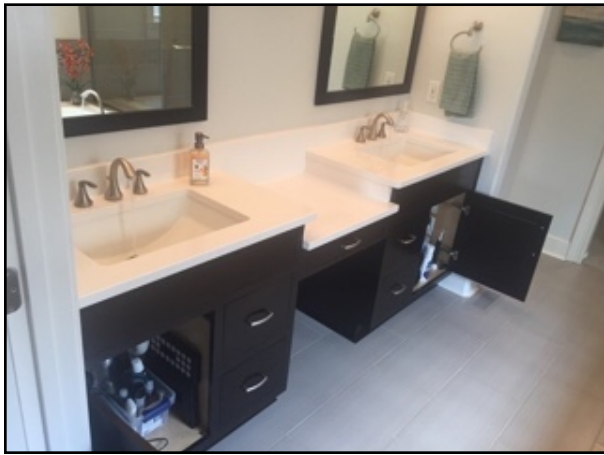
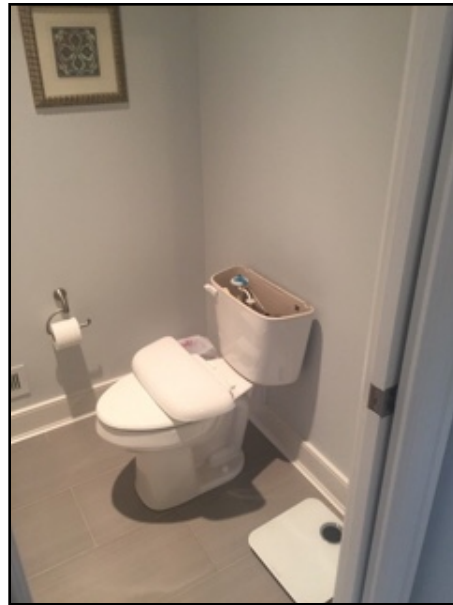
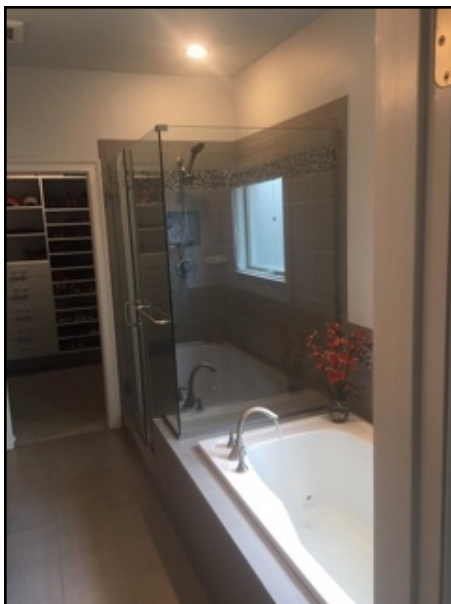
Master bath fixtures operate as expected. Ok.

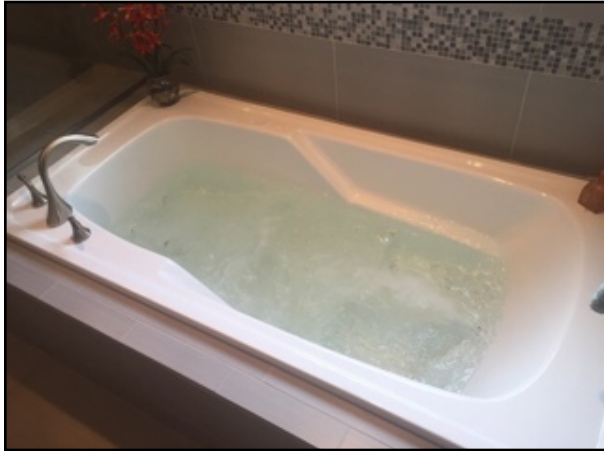
Figure 25-1

- i** Comment 25:
Whirlpool tub operates as expected. Fill and run with 2 cups of bleach for 15 minutes to clean and then refill with plain water and run to rinse.

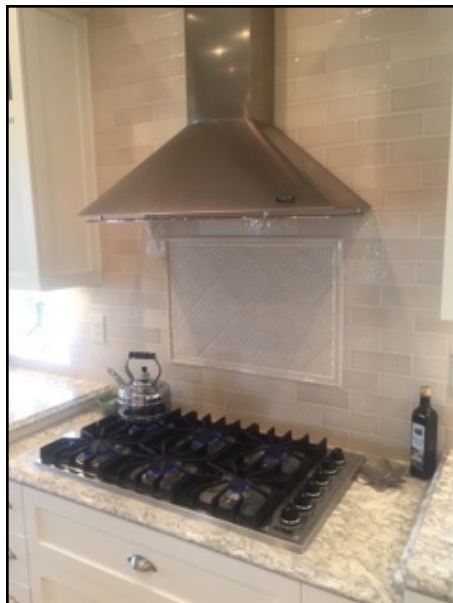
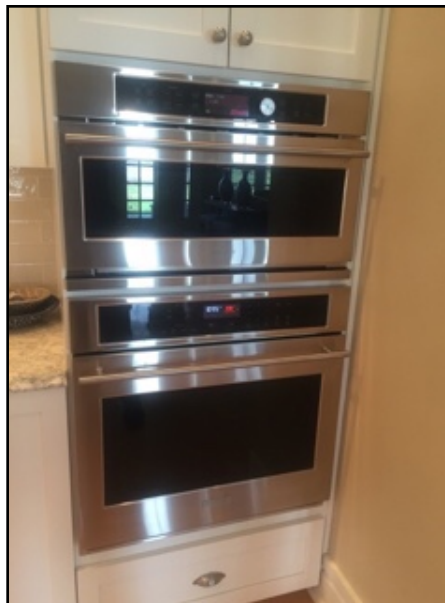
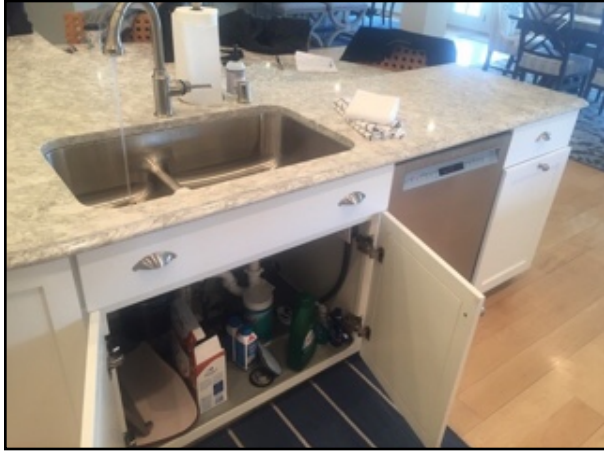
Comment 26:
Appliances operate as expected except as otherwise noted. Ok.

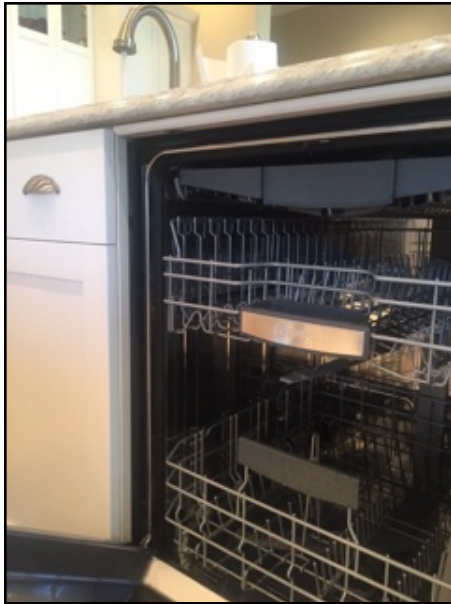
Figure 27-1

Dishwasher is not secured to counter. Have fully installed, leveled and operation verified before closing.

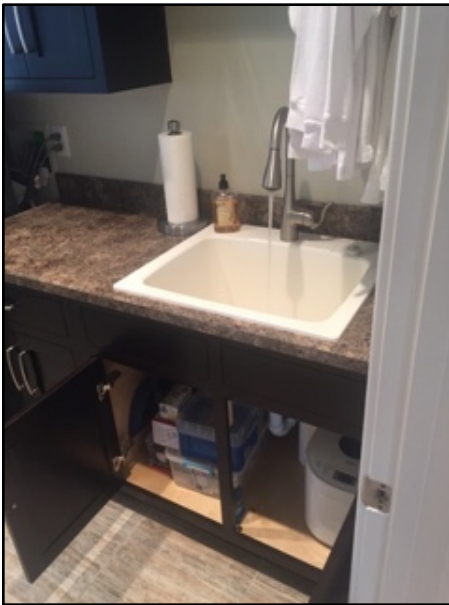
Figure 28-1

Comment 28:
Laundry sink operates as expected.

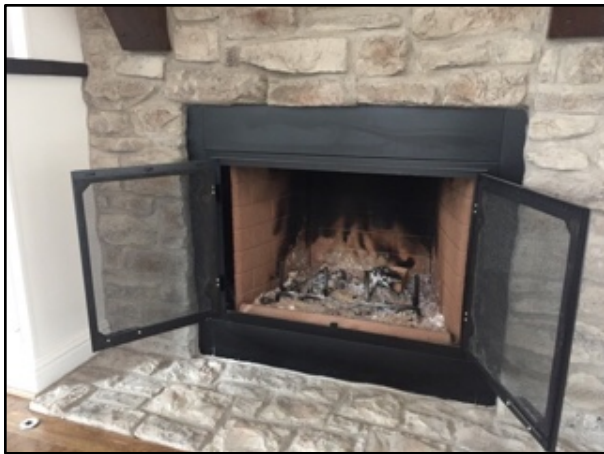
Figure 29-1

Wood burning fireplace is in acceptable condition. Ok. Have cleaned yearly by chimney sweep if used.

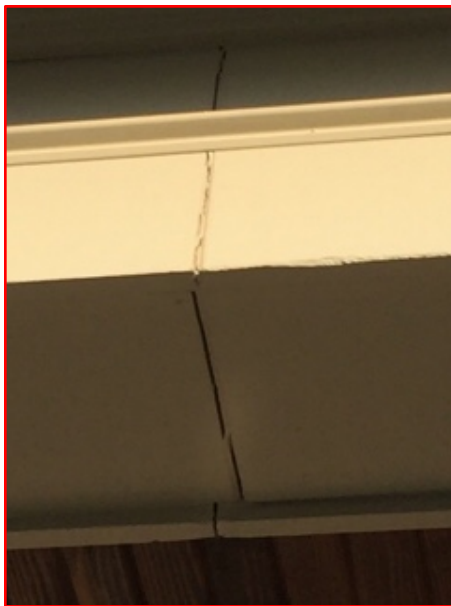
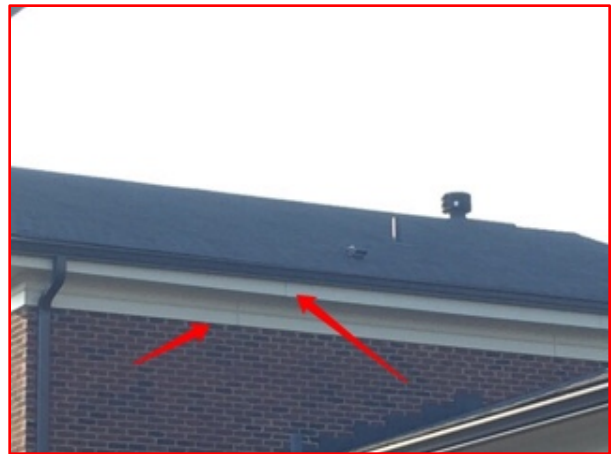
1) Several areas of gaps in exterior trim. Have caulked and painted to protect from weather.

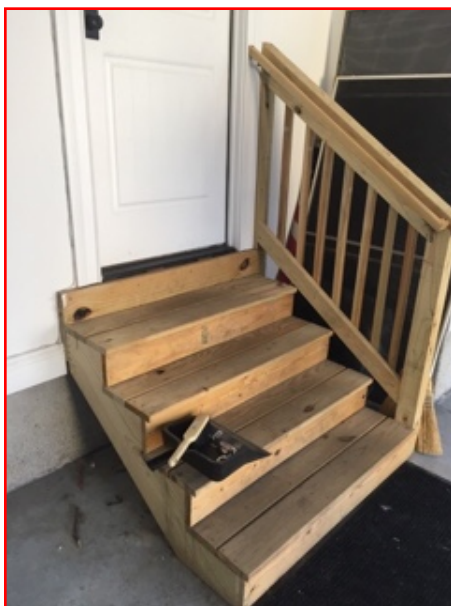
Figure 6-1

2) Steps in garage are missing handrail & guardrail. Install for safety.

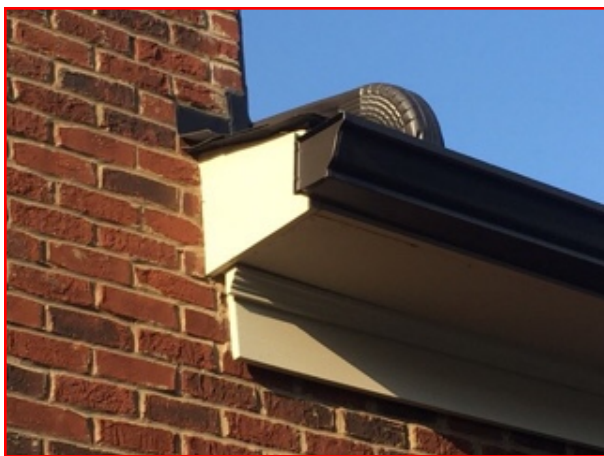
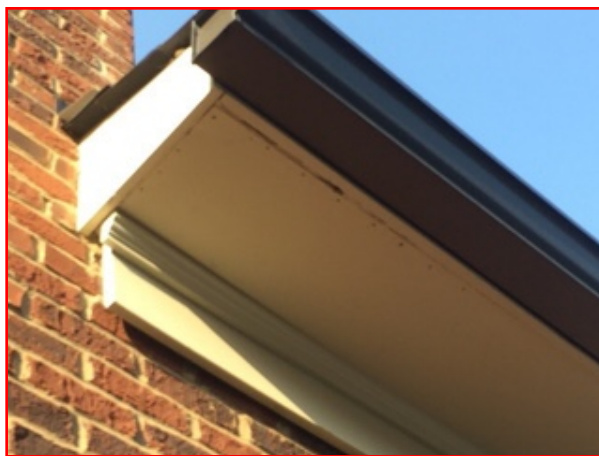
3) Prior repairs to rear right soffit. Have owner explain when and why repairs were made. Monitor.

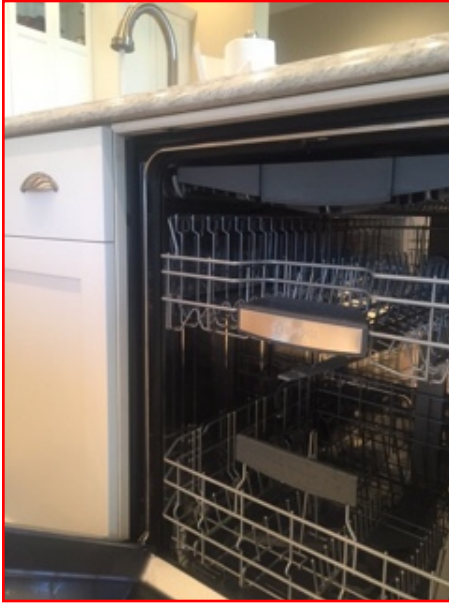
Figure 27-1

5) Dishwasher is not secured to counter. Have fully installed, leveled and operation verified before closing.
